CORRECTIVE ACTION PROGRAM FOR BROMOCHLOROMETHANE-CONTAINING "FIRE-SAFE" DIESEL FUEL

FINAL REPORT
AFLRL No. 81

U. S. Army Fuels and Lubricants Research Laboratory
Southwest Research Institute
San Antonio, Texas

September 1976

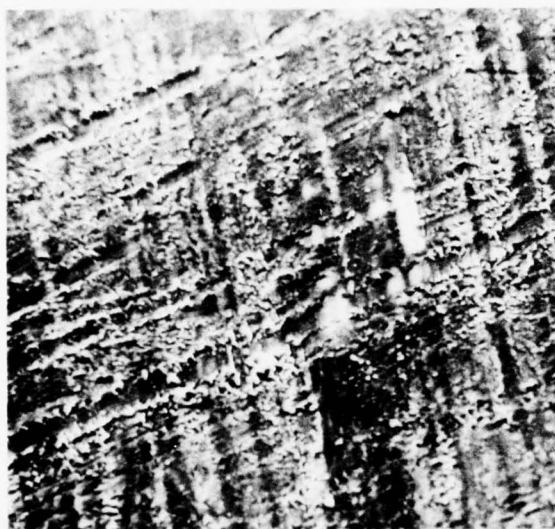
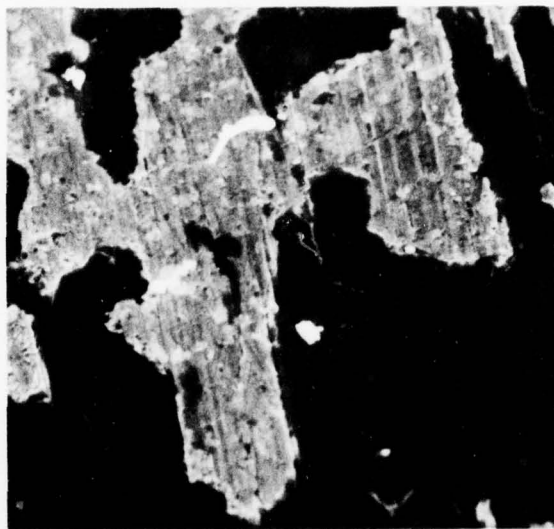
(a) Locations in dark zone of pintle

TABLE 4. MICROPROBE ANALYSIS OF
PLUNGER AND PINTLE

Element	Peak/Background ^a		
	Pintle Tip	Deposit on Pintle Body	Dark Band on Plunger
Mg	ND ^b	ND	^c
Ba	ND	ND	ND
Zn	ND	ND	ND
Ca	1600/1250	5300/3550	3900/1430
S	750/235	1136/240	160/107
P	ND	ND	71/56
Br	ND	ND	ND
Cl	566/214	5000/375	1010/170
Notes: ^a Counts in 30 sec., $i = 0.5 \times 10^{-7}$ amps. ^b ND—Not detected. ^c Mg preferentially located within pits P/B = 360/93 for reduced area scan.

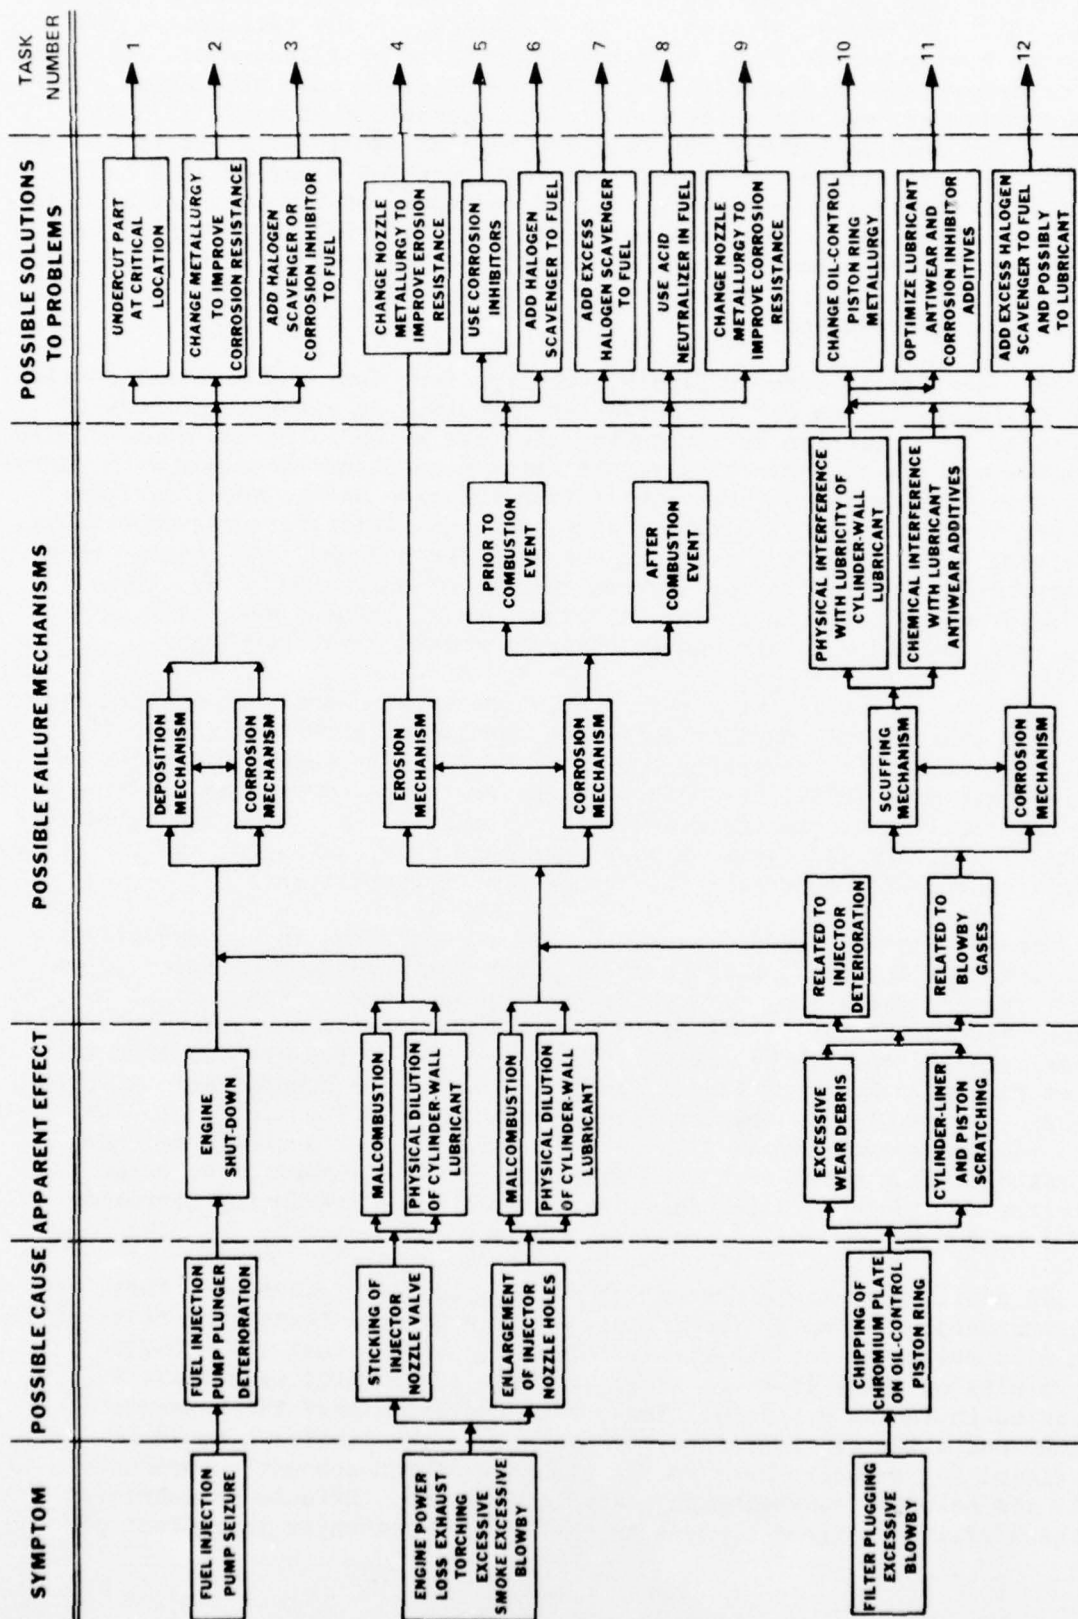
FIGURE 14. PLAN FOR CORRECTION OF HARDWARE FUEL INCOMPATIBILITY
AVDS 1790-2C/BCM FSF

The flow chart presented in Figure 14 was developed to place the various aspects of the AVDS 1790-2C hardware-fuel incompatibility problem in proper perspective. For the MERADCOM/AFLRL corrective action program, tasks 5-9 and 11-12 were selected for investigation (where the numbers correspond to those shown in Figure 14 under "Task No.").*

*Task No. 4 was not selected because it was learned that the AVDS 1790-2C nozzle vendor conducts proof-tests of nozzles at twice the maximum rated flow rate without seeing evidence of corrosion. This is hydrodynamically equivalent to doubling the fuel density; hence, erosion should not be expected because of the more dense fuel.

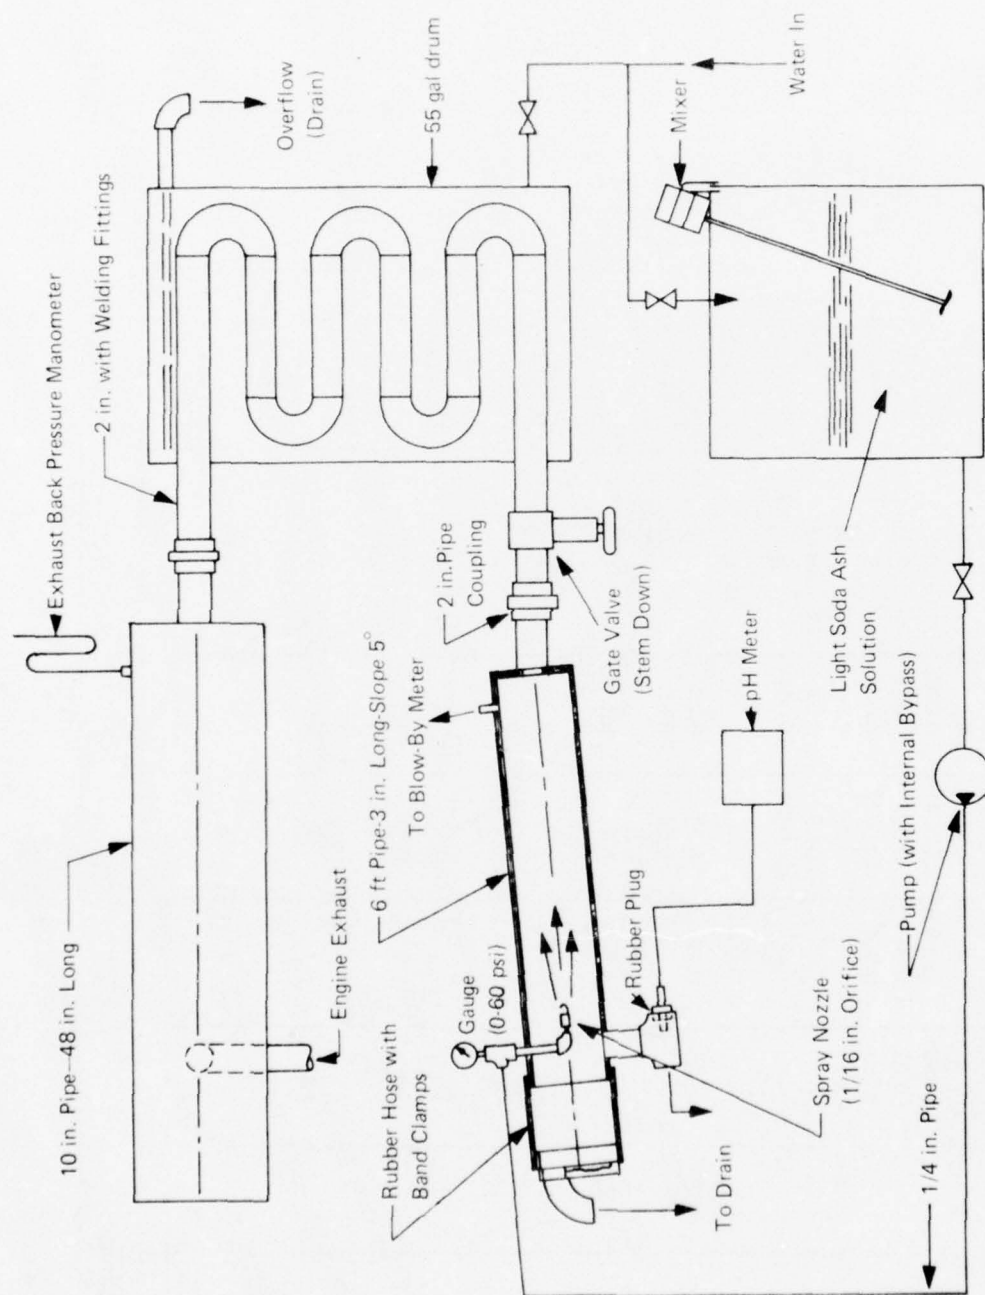
FIGURE 17. EXHAUST SYSTEM FOR TARADCOM ER-3 DIESEL ENGINE

A series of six 40- to 80-hour tests was conducted with the TARADCOM ER-3, single-cylinder, four-stroke cycle, diesel engine. The study was conducted to evaluate the effects on fuel injector nozzle tip hole enlargement and piston ring distress of using BCM FSF with and without halogen scavenger in the fuel and/or lubricant. The mechanical effects observed after these tests are summarized in Table 17, and the results of the lubricant analyses are detailed in Table 18. For each test in this series, the ER-3 engine was (a) rebuilt to include new bearings, a new cylinder sleeve, and a new piston/ring assembly, (b) installed on a laboratory dynamometer test bed, and (c) given a standard break-in using neat CAT 1-G/1-H reference fuel and the same MIL-L-2104C lubricant as that used in the multicylinder tests. Also, to prevent contamination of the laboratory and/or its exhaust dilution system when operating the engine on BCM FSF, a commercial exhaust scrubbing device, having a maximum gas flow capacity of 2.27 m³/min (80 cfm), was inserted in the engine exhaust line. During the test series, this device required extensive modification to maintain its reliability and efficacy. The final version of the ER-3 exhaust system is illustrated in Figure 17.

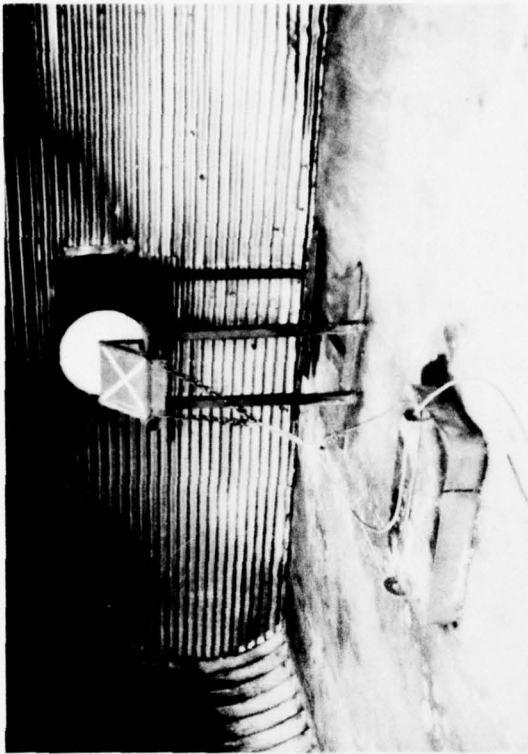
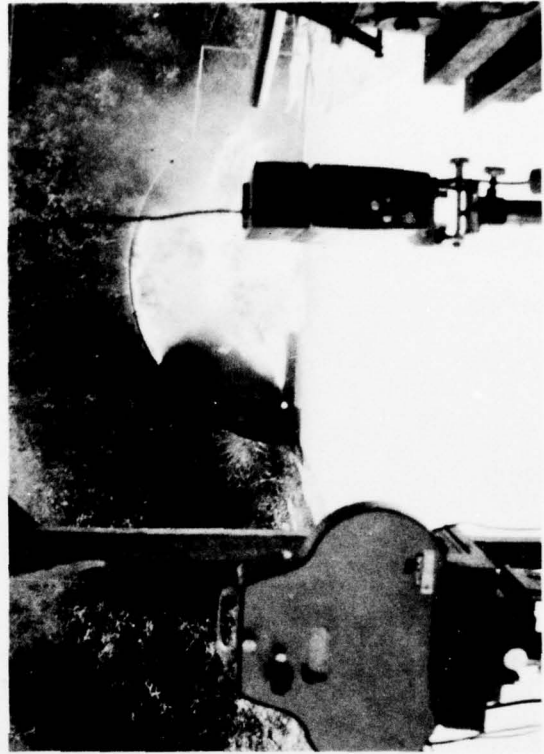
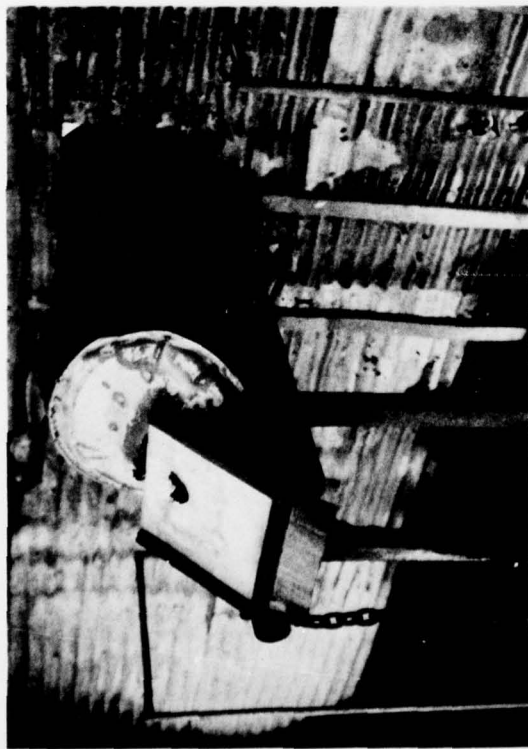
FIGURE 20. PHOTOGRAPHS OF BALLISTIC TEST AND SPENT TARGETS

A series of replicated ballistic tests was conducted by AFLRL to tentatively establish the efficacy of 5% BCM FSF at a realistic maximum fuel tank temperature of 77°C (170°F) (Figures 19 and 20). These tests comprised the firing of 20 mm HEIT rounds horizontally into 76 liters (20 gal.) of fuel contained in a 114-liter (30 gal.) horizontally-mounted drum. A tilted (45°) aluminum plate was mounted 30 cm (1 ft.) in front of the drum face so that the 1000 m/s projectile would penetrate its center and become actuated before striking the center of the drum face below the liquid level. The results of these tests indicated that BCM FSF [5% (liq. vol.) BCM in a 63°C (145°F) flash point diesel fuel] did not experience sustained ground fires, but did exhibit flash fireball effects. The test results also demonstrated that the presence of 1% cyclohexene oxide (candidate halogen scavenger) in the BCM FSF did not adversely affect the ground-fire flammability resistance of BCM FSF.
